Manhole Inspection Summary

Manhole # S11Y__024MH

Insp Date: **4/7/08 12:50 PM**

Location Address: **3410 Benson Ave**

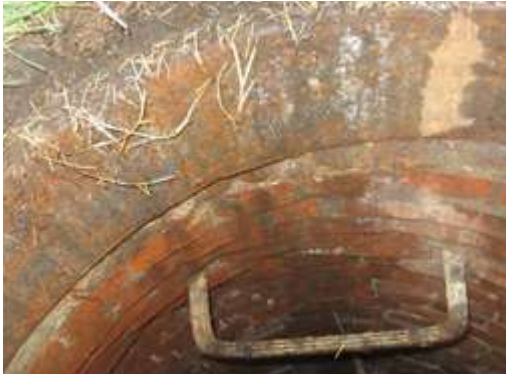
Defect 1

☒ **Leaks**

Infiltration: ☐ None ☐ Joint ☐ Cracks ☐ Mortar ☐ Roots ☒ **Wall**

evidence of chimney and corbel infiltration, frame leaking

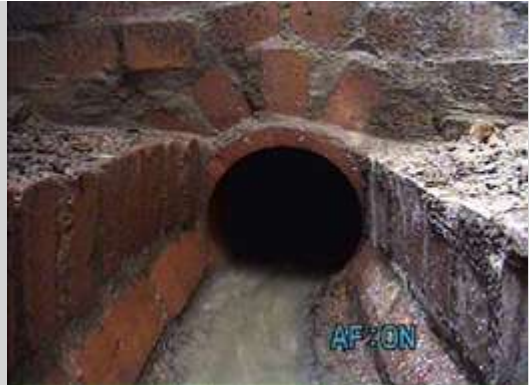
12 O'Clock Outflow

8 in. Circular Gravity Sewer
Pipe Out @ 12 O'Clock

Pipe Height: **8.4** (in.) Rod and Bar (Angled)
Pipe Material: **Clay** ☐ Pipe Lined
Invert Depth: **9.09** (ft.) Flow Characteristics: **Fast**
Deposits: ☒ None ☐ Mud ☐ Sludge ☐ Debris ☐ Grease
Silt Depth: **0** (in.) Deposits Extent:
Infiltration: **None** Pipe Seal Cond: **Sound**

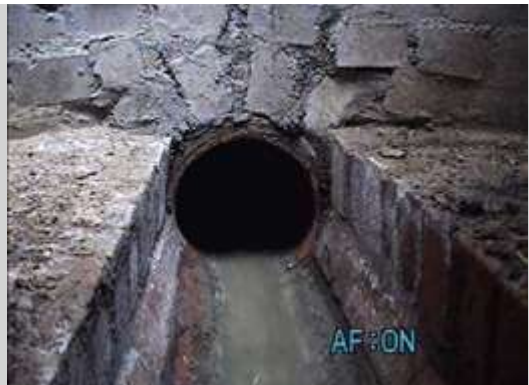
6 O'Clock Inflow

8 in. Circular Gravity Sewer
Pipe In @ 6 O'Clock

Pipe Height: **7.2** (in.) Rod and Bar (Angled)
Pipe Material: **Clay** ☐ Pipe Lined
Invert Depth: **8.94** (ft.) Flow Characteristics: **Fast**
Deposits: ☒ None ☐ Mud ☐ Sludge ☐ Debris ☐ Grease
Silt Depth: **0** (in.) Deposits Extent:
Infiltration: **None** Pipe Seal Cond: **Sound**
